# Balzac

***Bronze corrosion and patina analysis***

The following slides are produced utilizing excel over lays of spectra taken on the Balzac sculpture in June before the statue was re patinated.

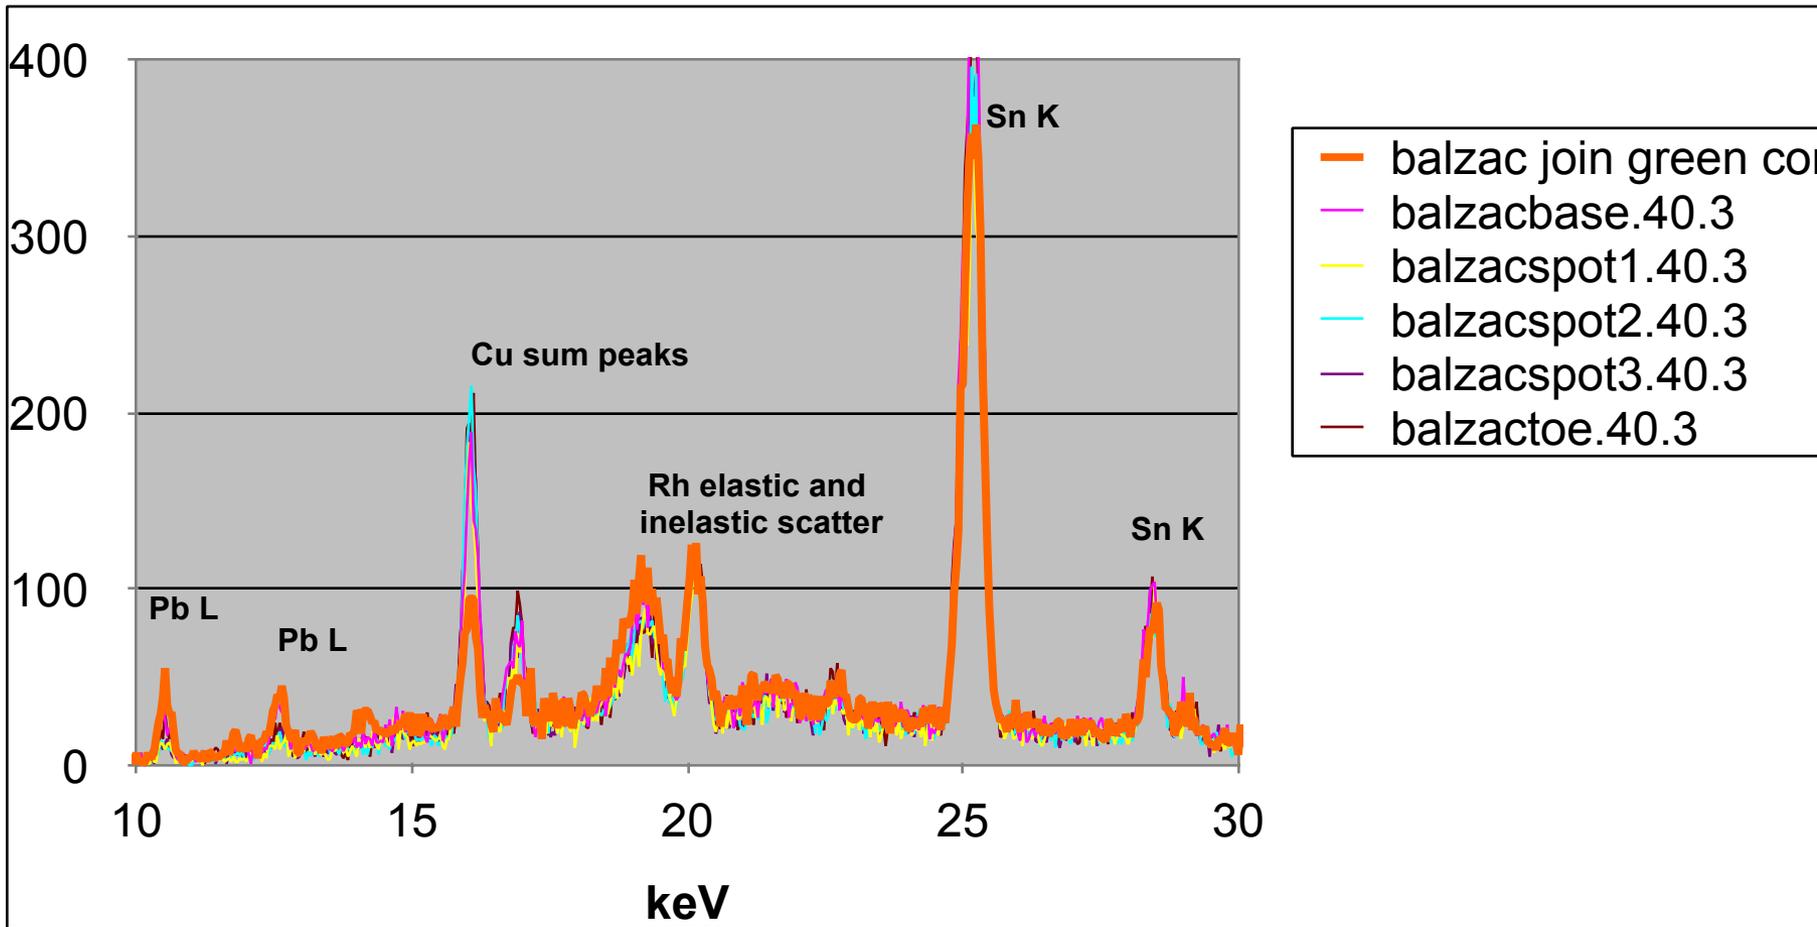
The Cu alloy contains a small amount Zn, Sn and a trace of Pb. See next slide for Cu and Zn

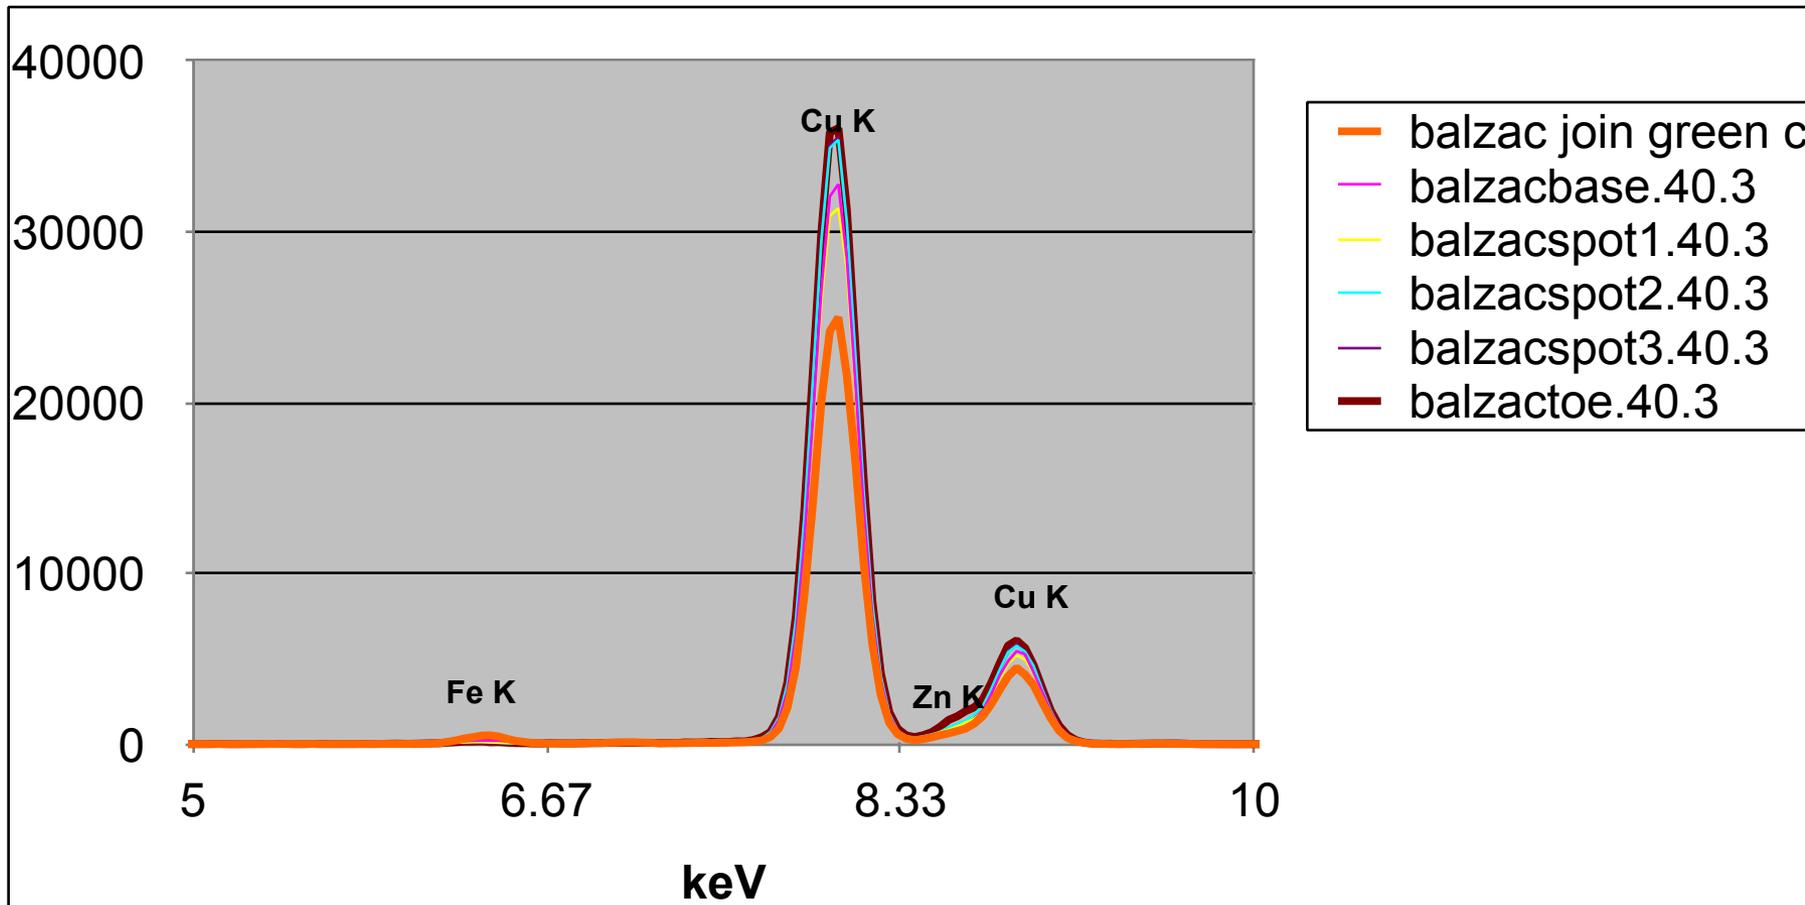
The Cu from the bulk alloy is attenuated depending on the thickness of the corrosion. Based on this the corrosion is thickest in the joint.

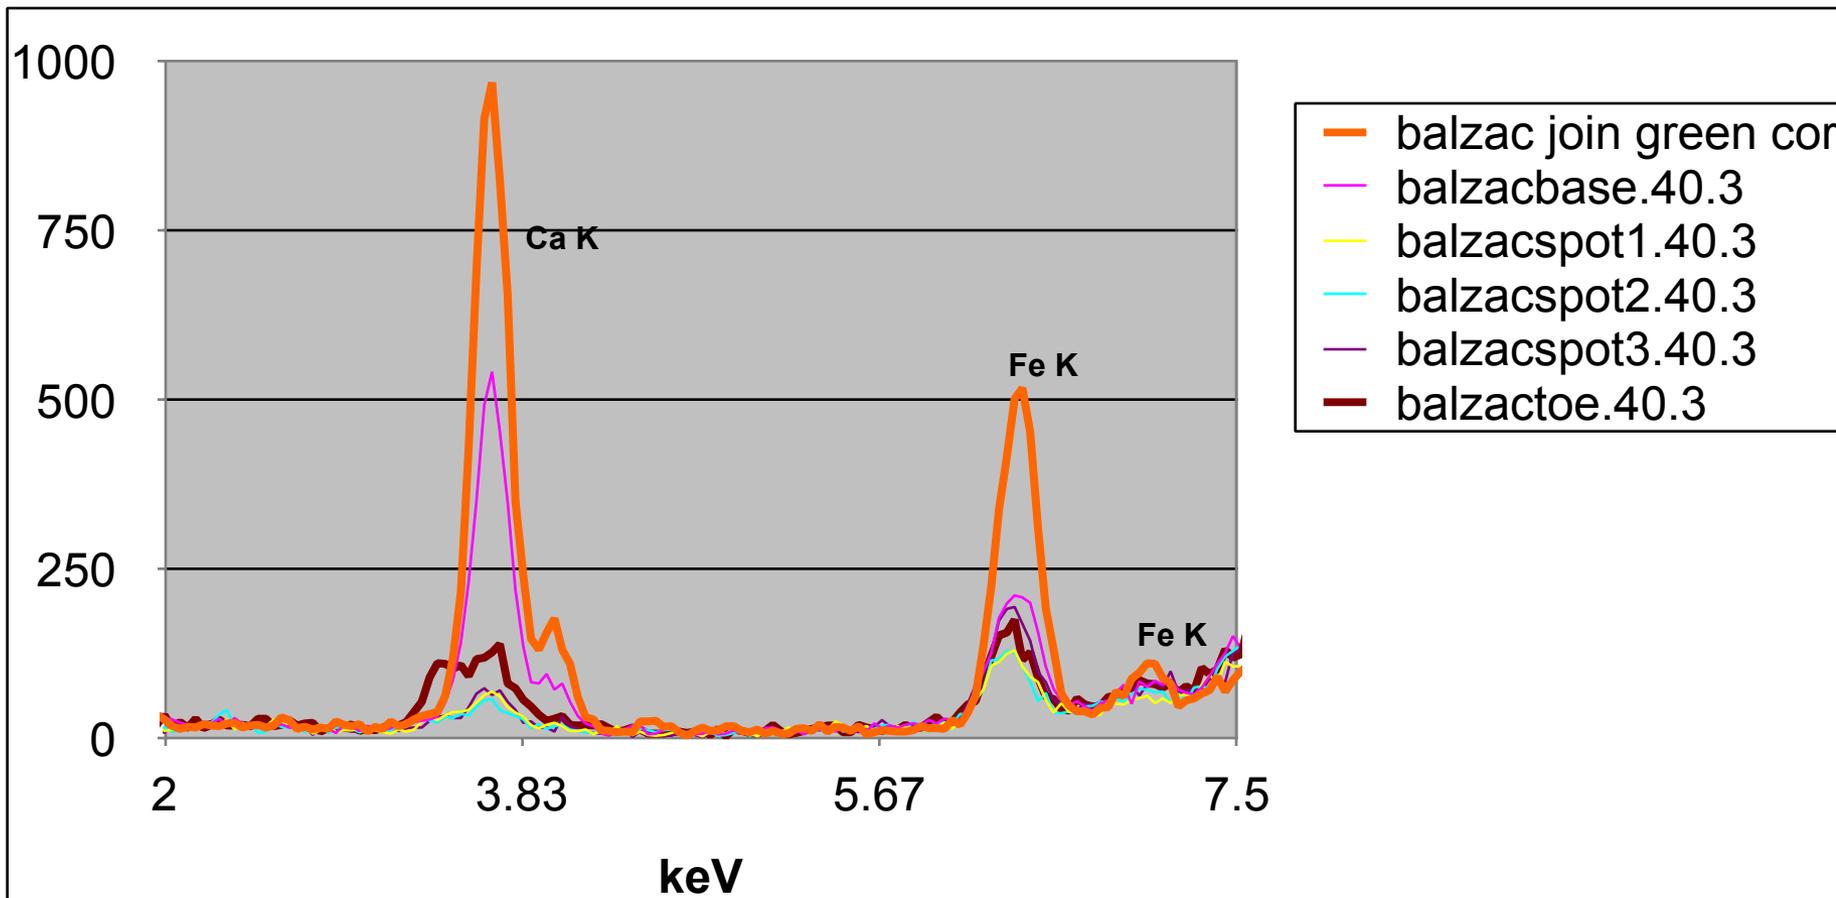
The join contained Fe and Ca build up,. Likely the product of water from sprinklers drying over the years.

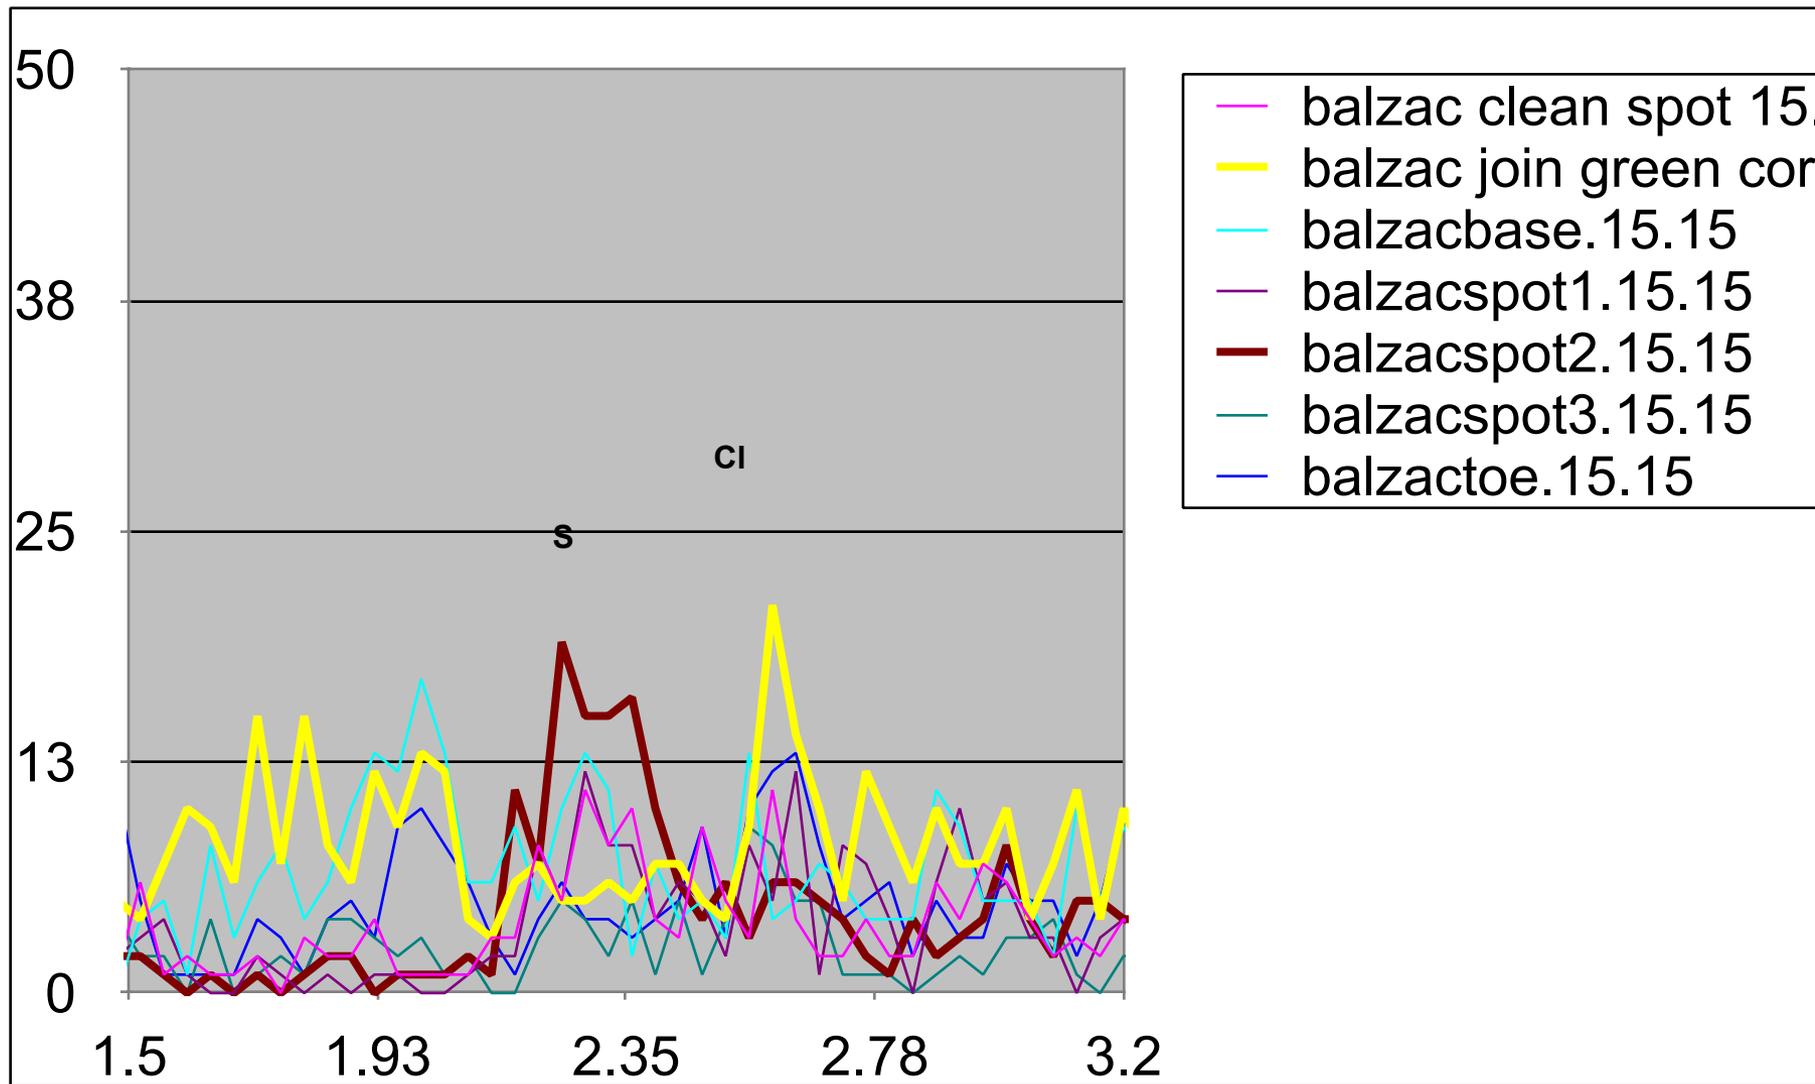
There is a trace of Cl in the joint and a trace of S in spot 2.

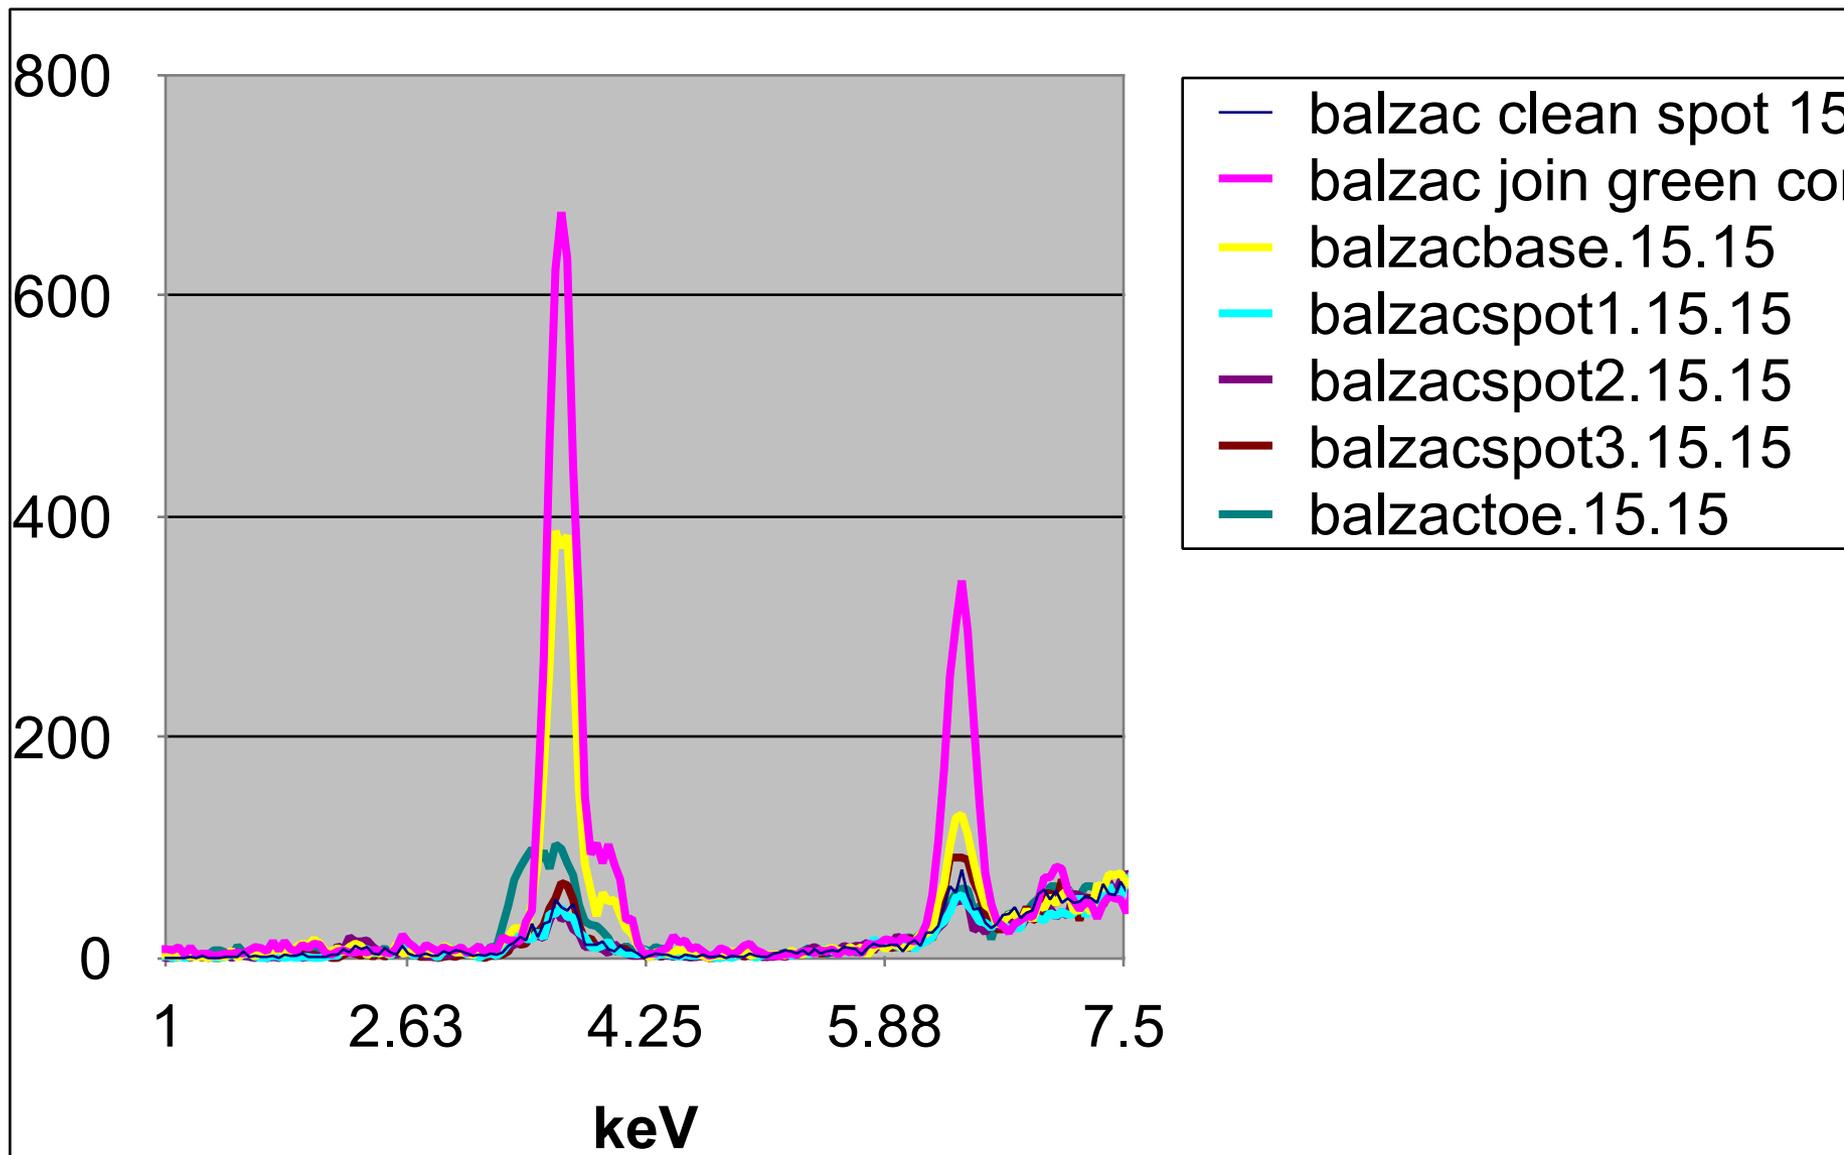
The join contained Fe and Ca build up,. Likely the product of water from sprinklers drying over the years.
